## Council

FROST PARK - DRAINAGE

Attachment One - Photos

## Frost Park – Drainage Photos – 26 August 2020

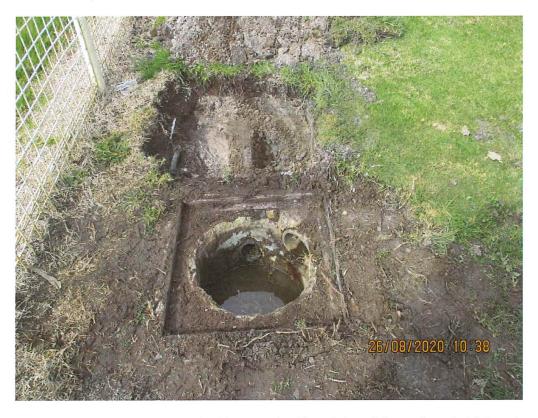
Pavillion roof water collection sump looking south. Note inlet of downpipes is higher than inlet of subsoil. Outlet from sump (not shown) is higher than subsoil piping.

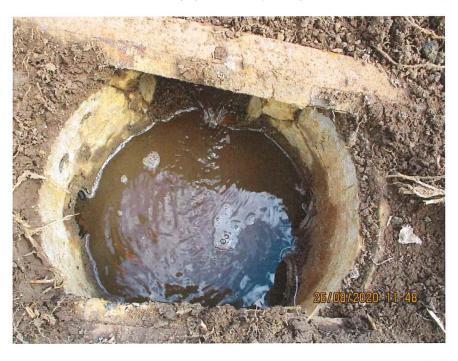
Ag Shed water collection sump. Note that LHS subsoil pipe leads back towards Pavillion and is lowest point in the sump. ie Flow is backwards to what it should be.

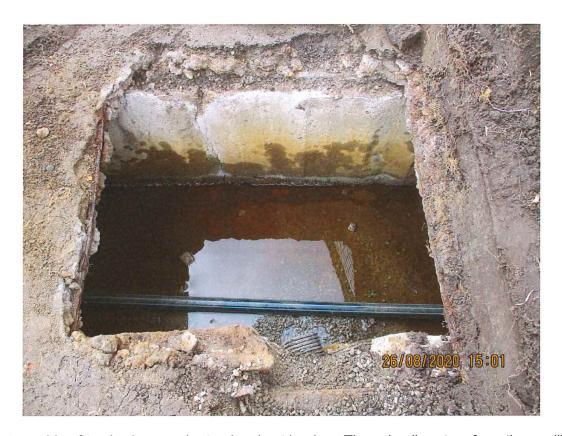
Western side of track where under track culvert begins. The subsoil system from the pavillion area is supposed to terminate here but note that there is no water flow.

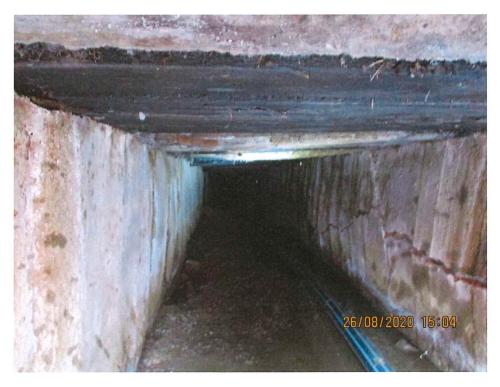
Looking eastwards under track through culvert system. Note rotted and cracked timber, cracked and bowing side walls. Some grass roots can be seen growing down through the lid.
