Local Government Insurance Service  
Preliminary Liability Risk Advice  
Wilson Park, Mount Barker

**Preliminary Liability Risk Advice: Wilson Park, Mount Barker.**

**Shire of Plantagenet Wilson Park Site Inspection Photographs & Comments**

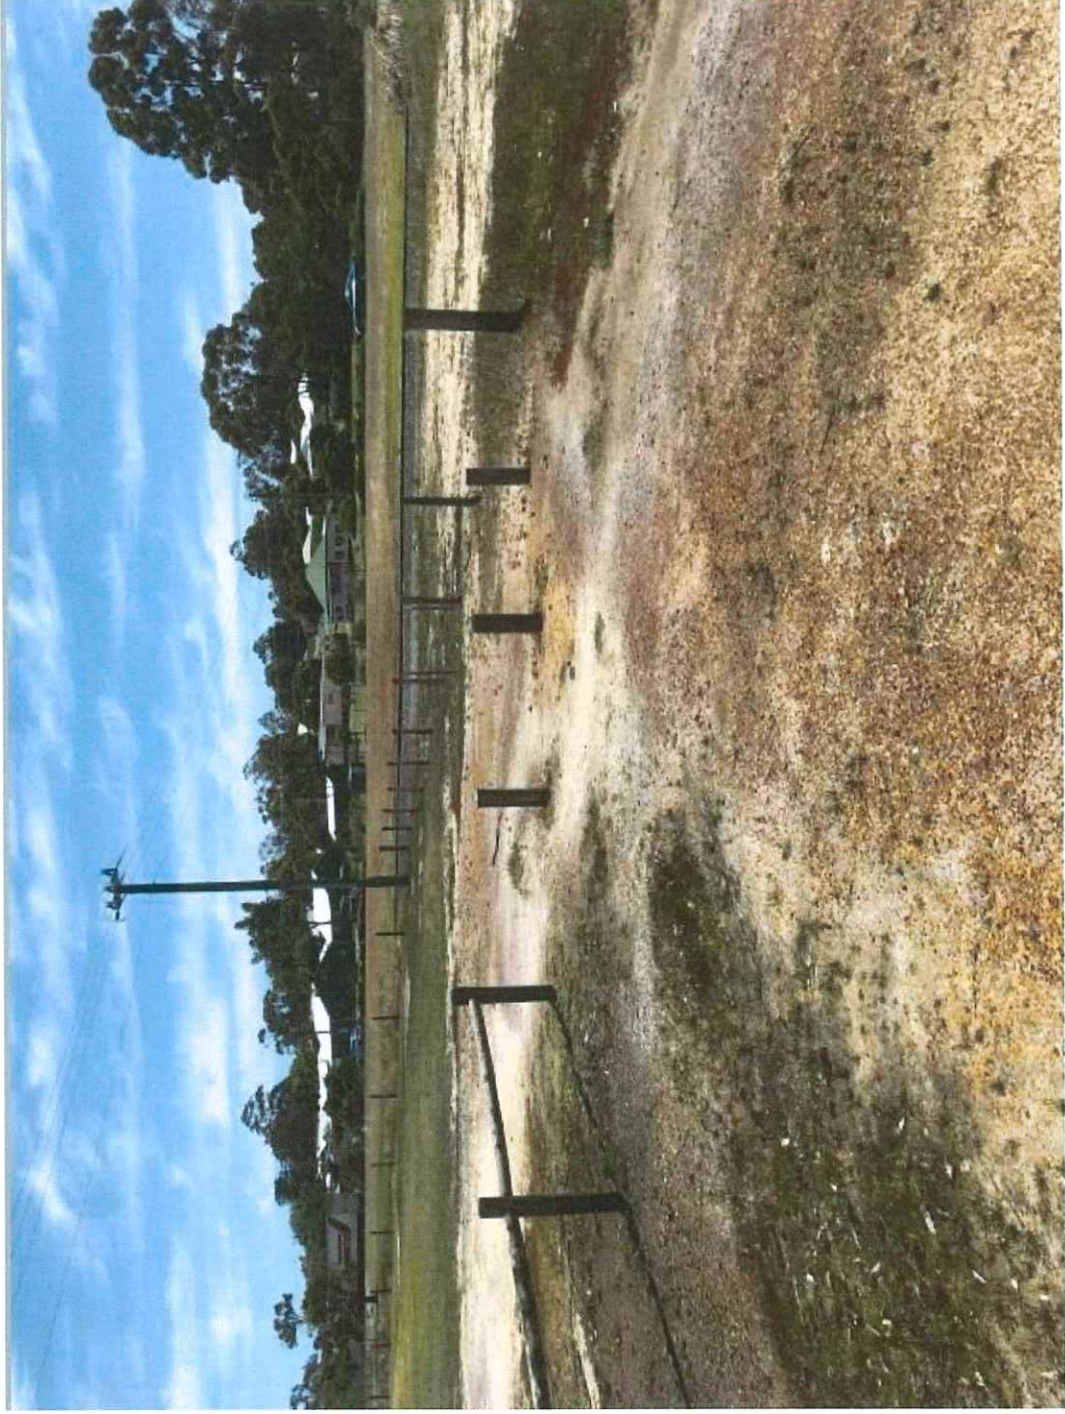
- At the south east, corner of Wilson Park the fence line angles back towards Montem Street where the fence design changes to treated timber pine posts with single horizontal rails. Some minor maintenance work may be required to fencing at this point.

South east corner of Wilson Park indicating rail line and commencement of treated pine fence to Montem Street. Some minor repair work is required to the steel wire to the fencing as it angles away from the rail line.

- Some minor repair work is required to fencing to the south east of the park.
- Parks and Leisure Australia (WA) in their publication Guidelines for Community Infrastructure makes mention in relation to accessibility indicating under General Principles that community facilities should be readily accessible to people of all abilities and be compliant with the requirements of the *Disability Discrimination Act 1992* and *AS 1428 Access & Mobility Design Set*. Given there may be future improvements to the park and surround this publication may be a useful tool during any planning and design process.

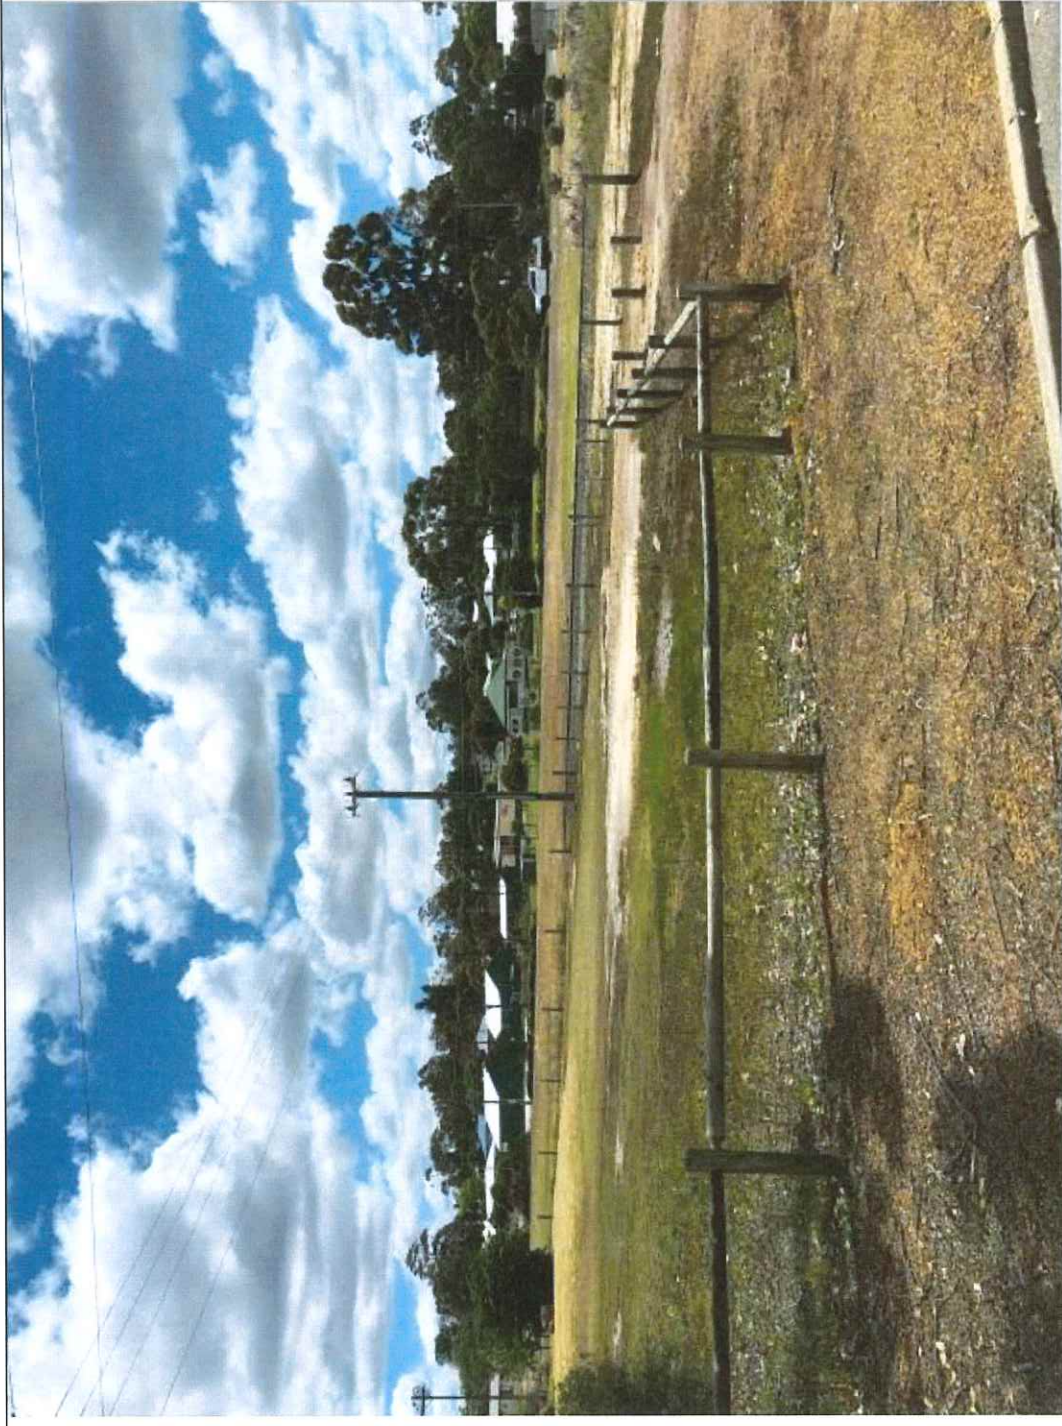
Nature of fencing to Montem Street.

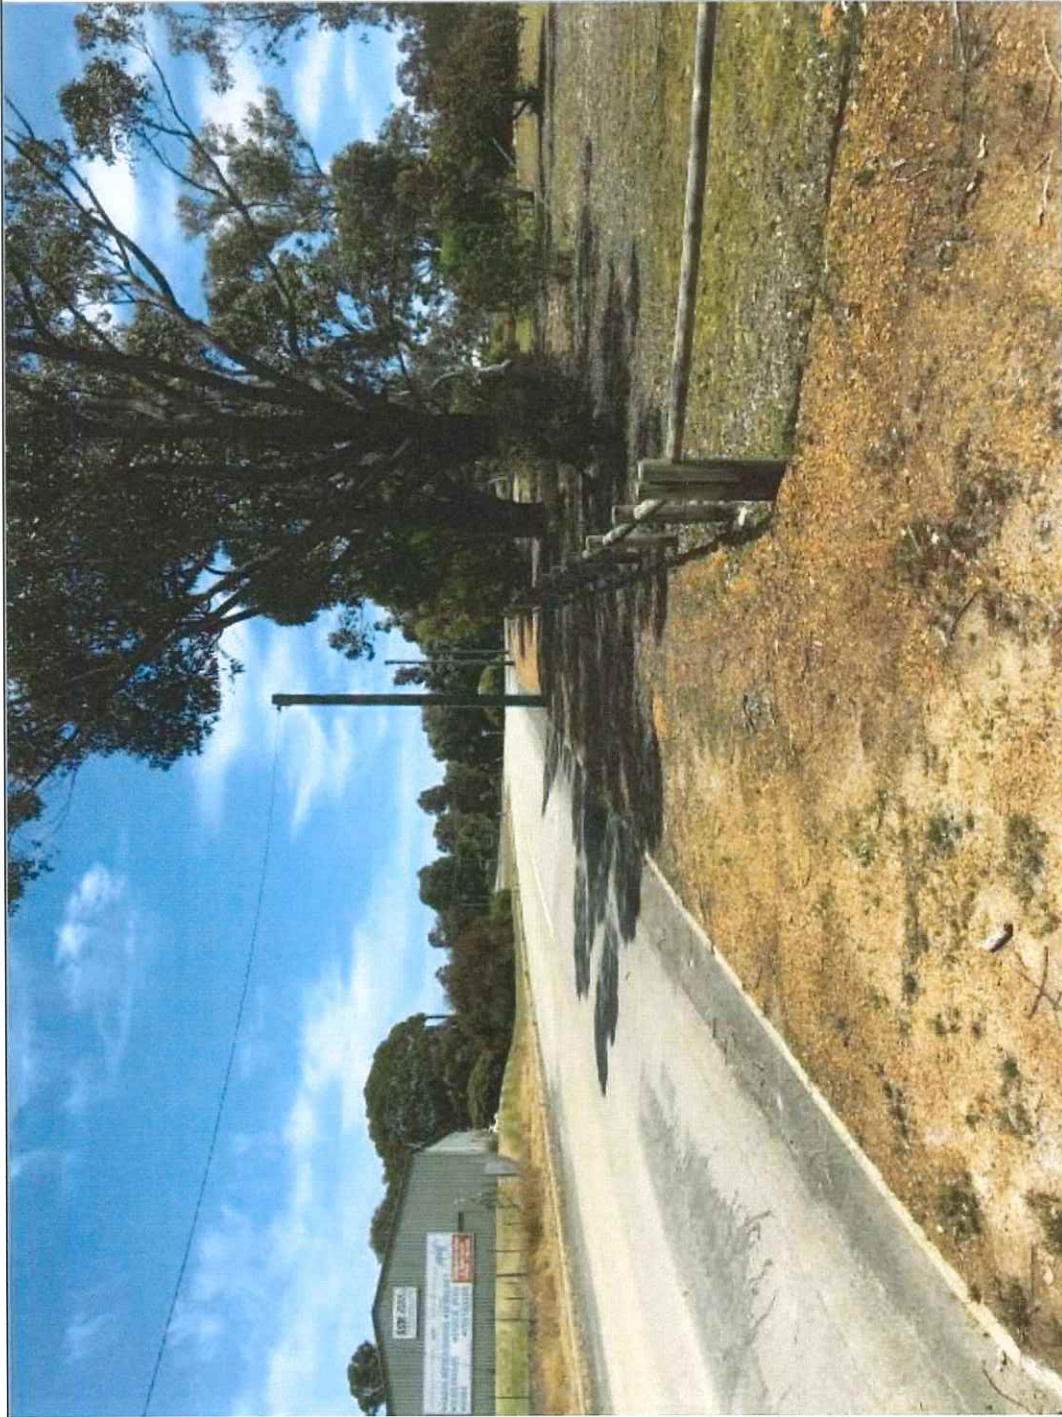
As above.

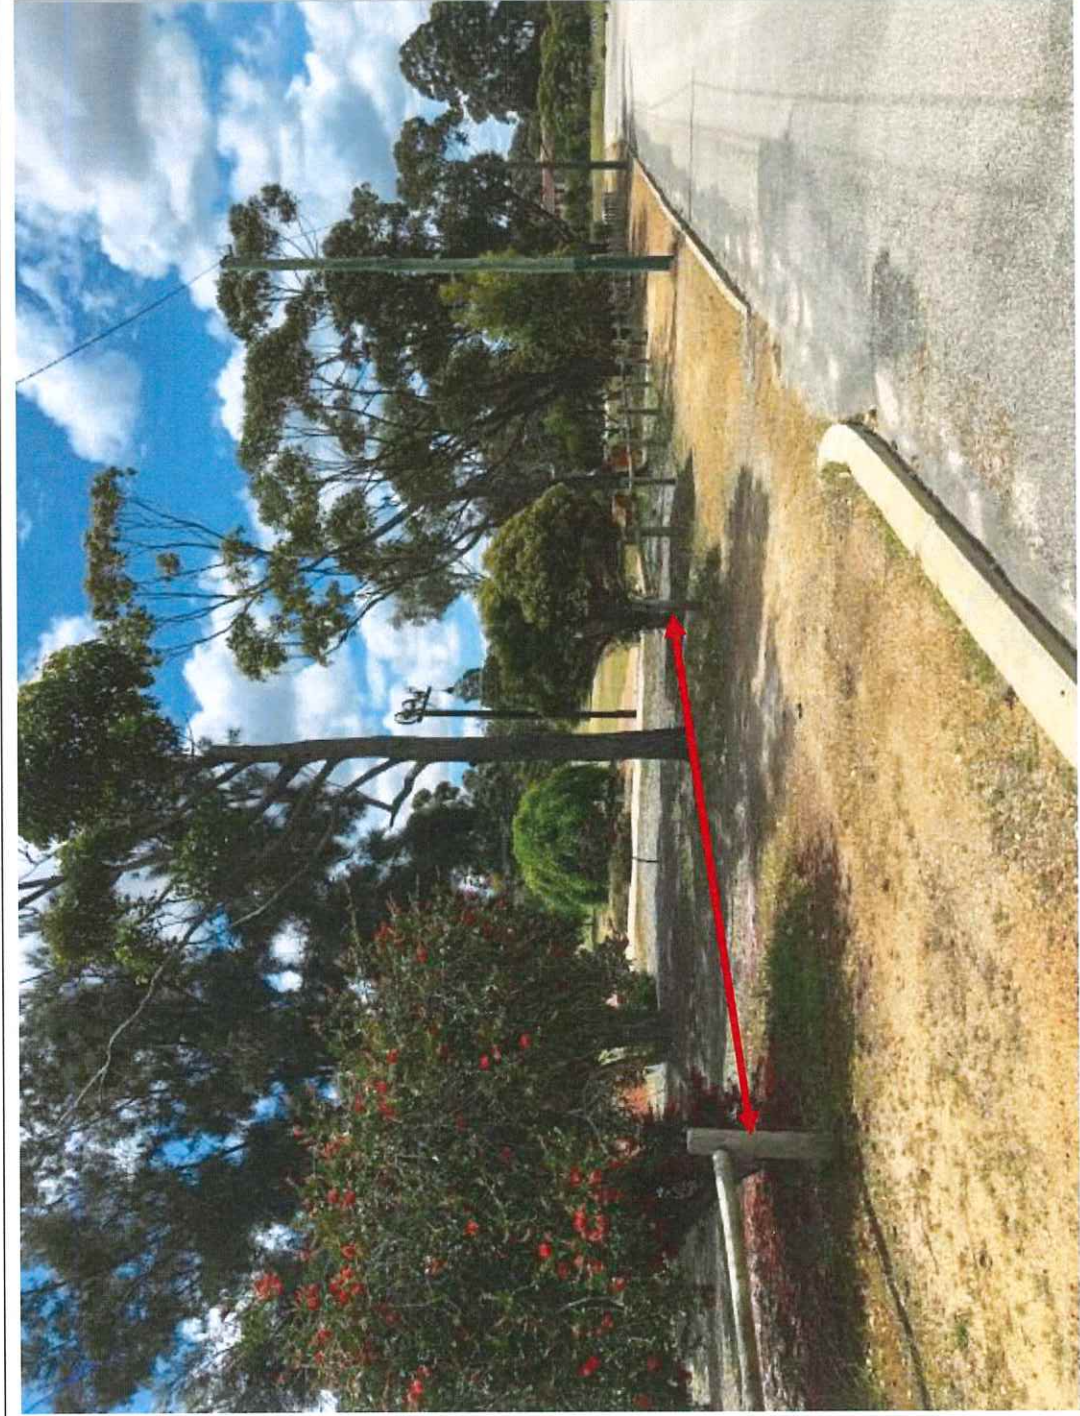
- The fence to Montem Street provides gaps including modified curbing to allow vehicle access into Wilson Park.
- As the timber, fence line on Montem Street approaches the junction with Lowood Road (broadly the southwest corner of the park) the type of fencing changes to steel tubular railings (sectional) which are concreted into the ground.

Vehicle access point into Wilson Park from Montem Street. Can this entry point be secured from unauthorized vehicles?

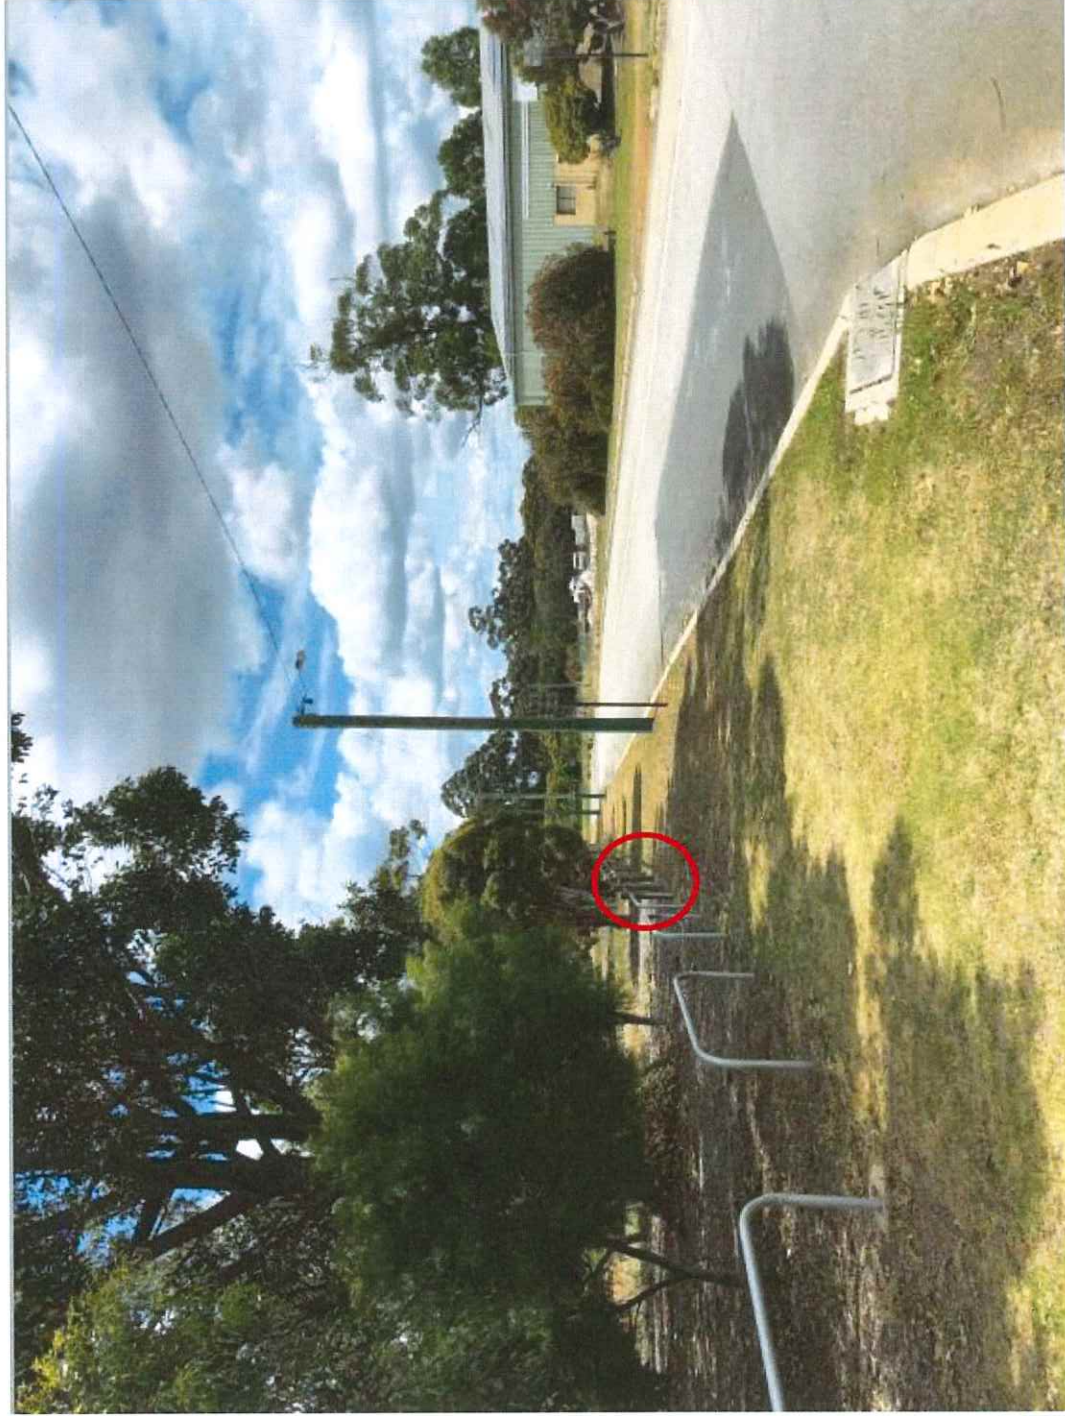
View of fencing along Montem Street indicating point where treated timber fence changes to rail fencing.

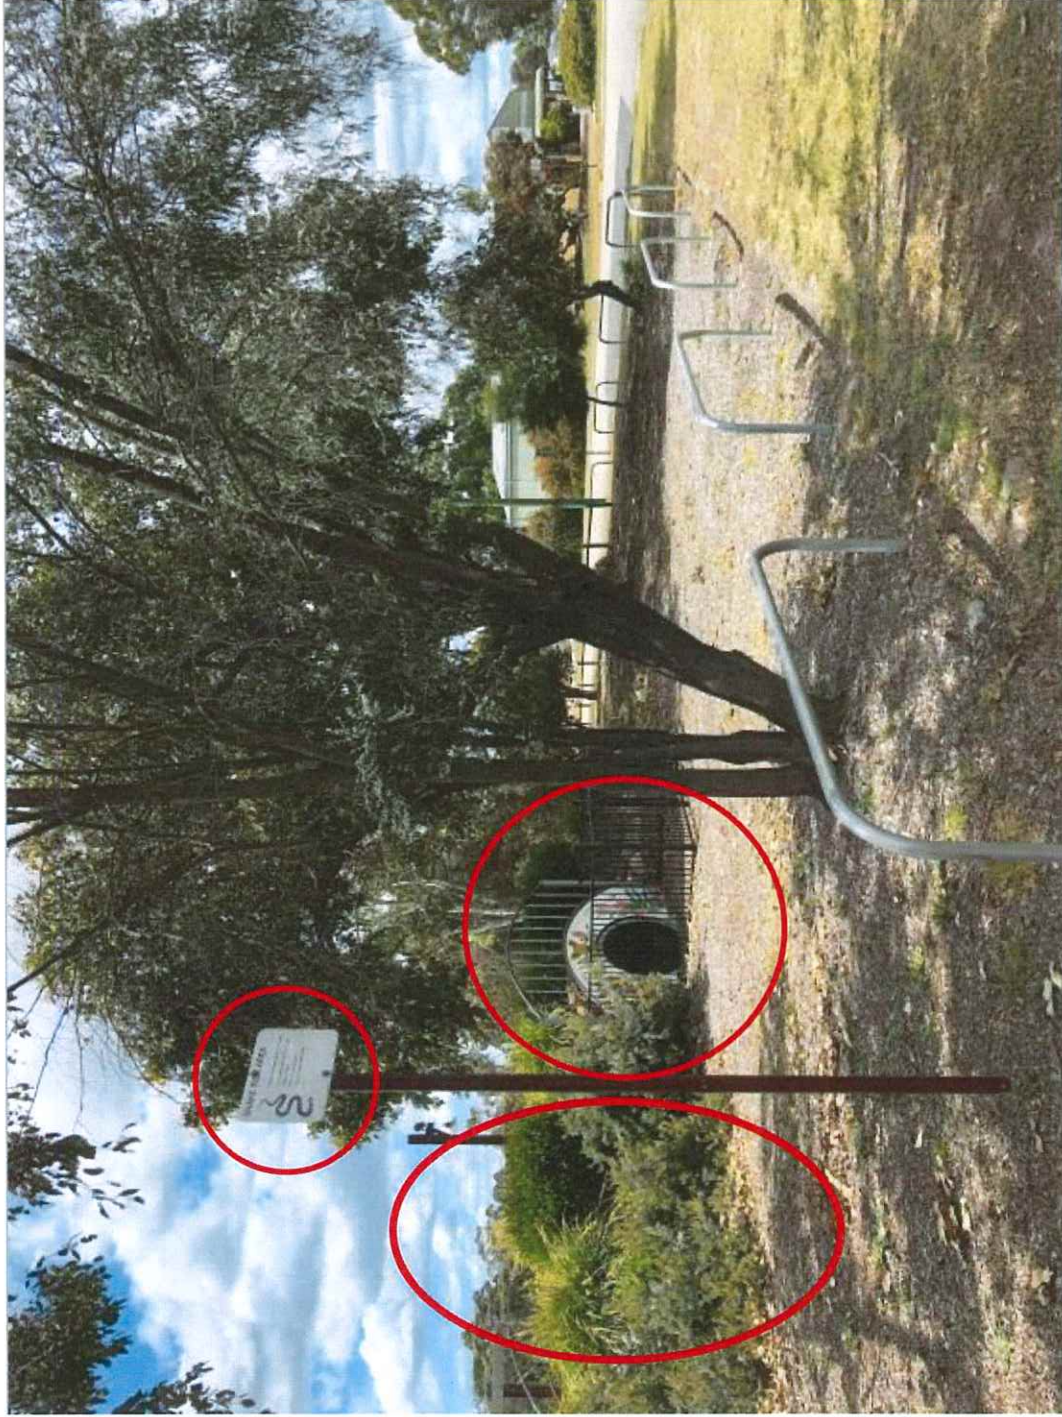
- In terms of the tunnel, which forms part of the broader play experience for children, given the exit point of the tunnel faces Lowood Road, Council have installed railed fencing with a latched gate to avoid younger children making their way onto the public highway.

View of exit point from tunnel leading from play area into perimeter of park and verge of Lowood Street. Note fenced area to exit point and signage indicating presence of snakes and vegetation

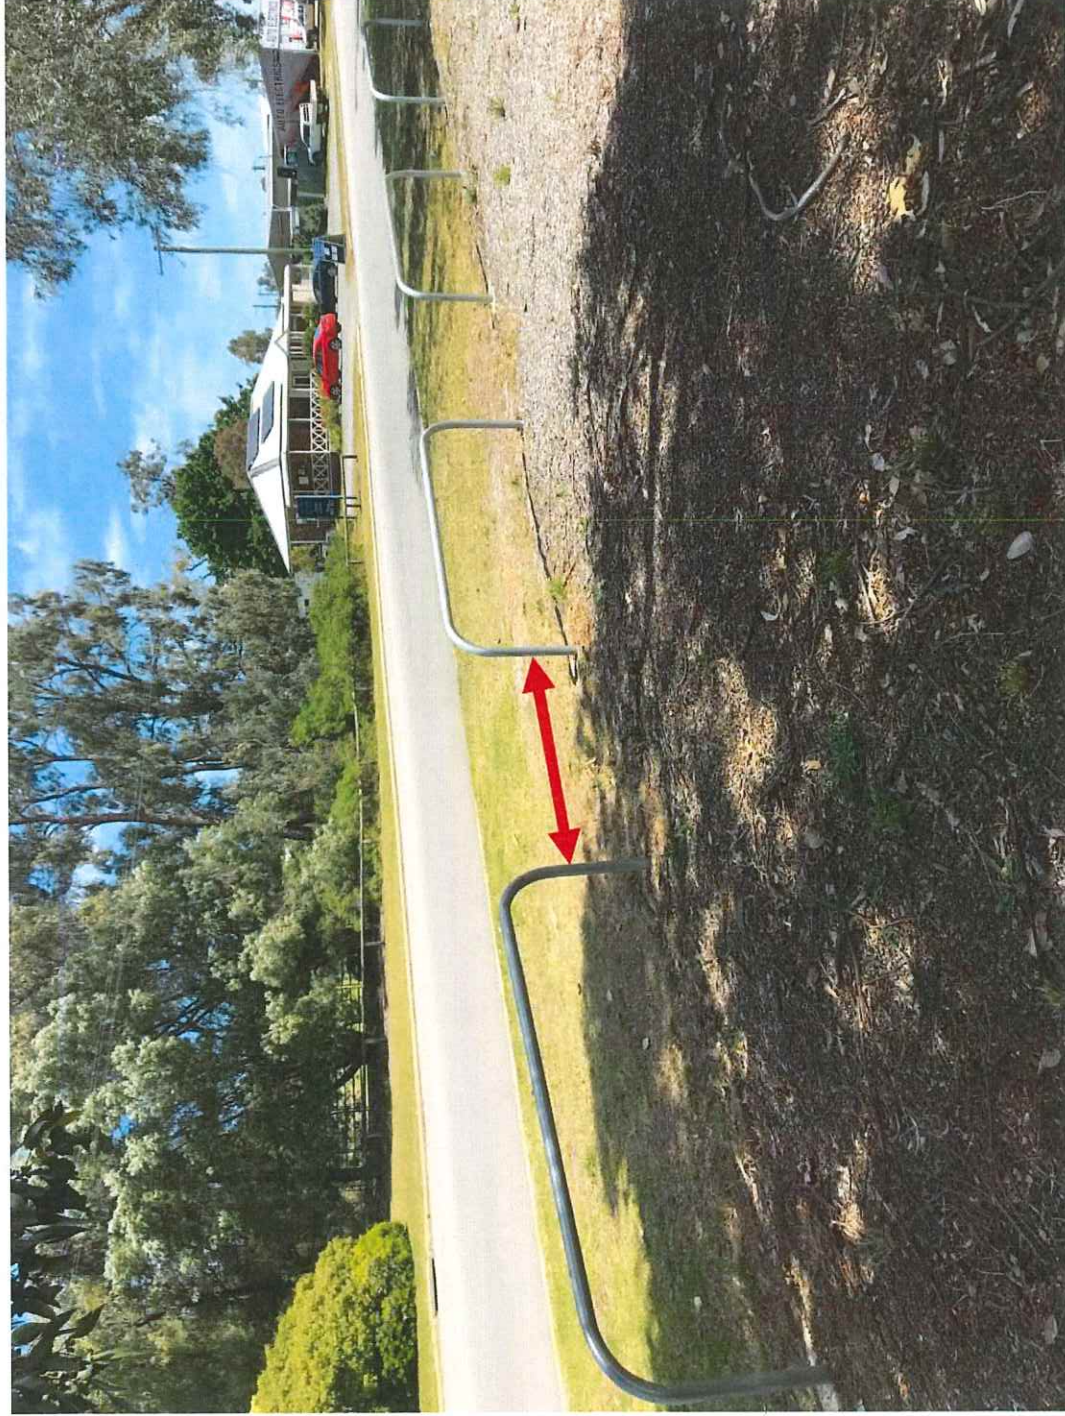
View from perimeter of Wilson Park looking across Lowood Street.

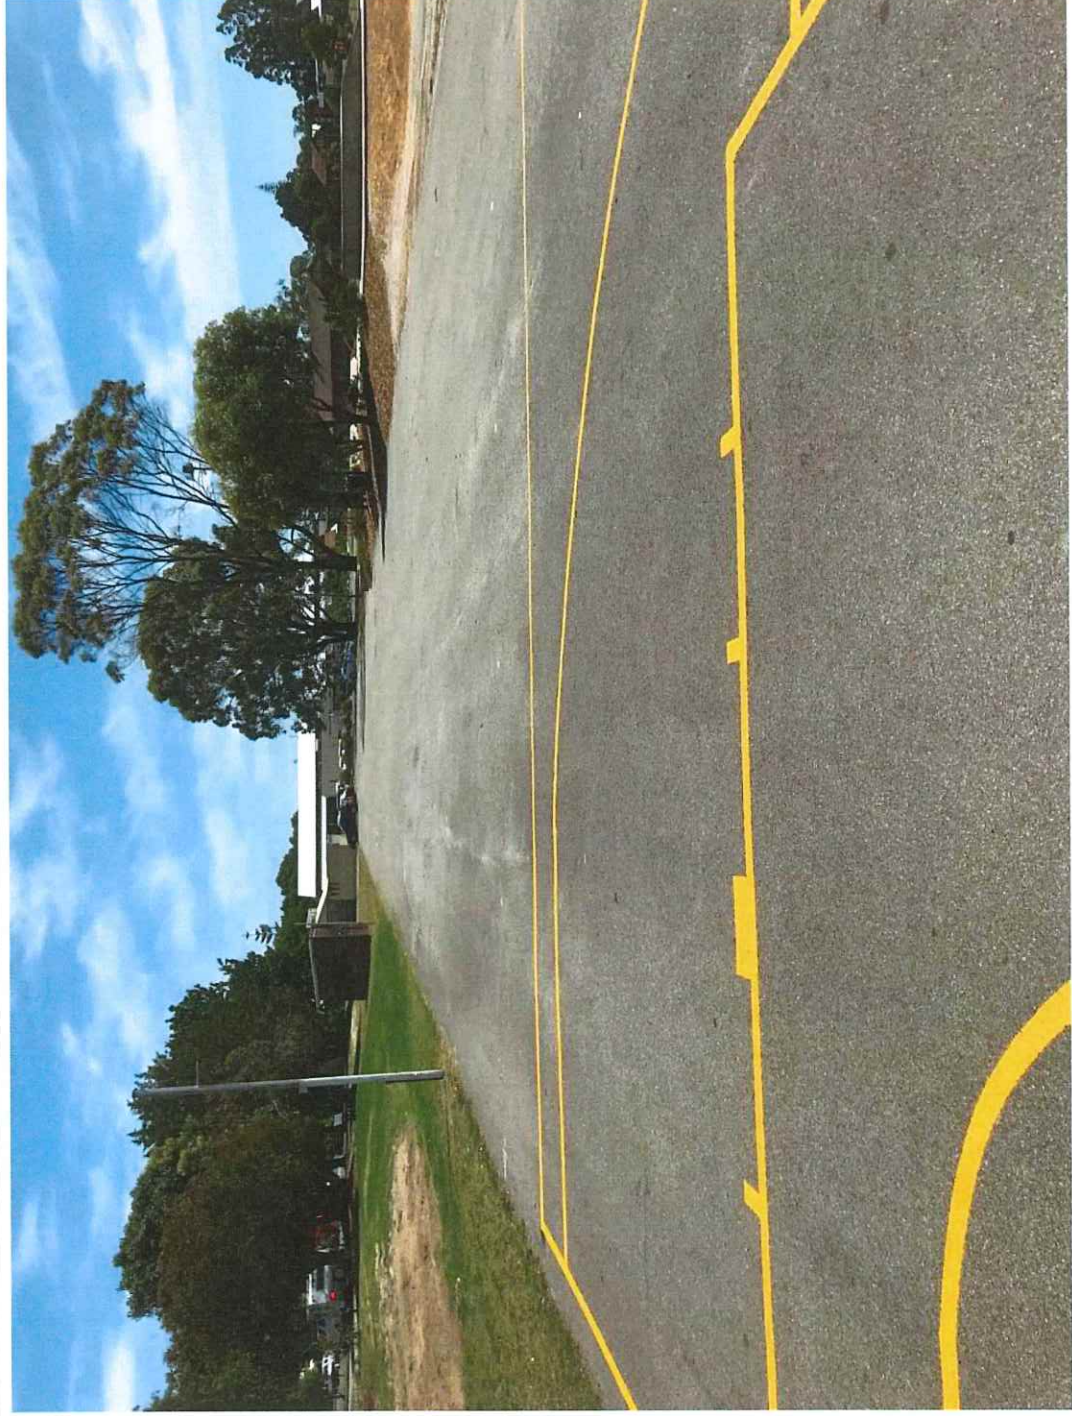
View looking away from Wilson Park towards Shire office, note basketball court.

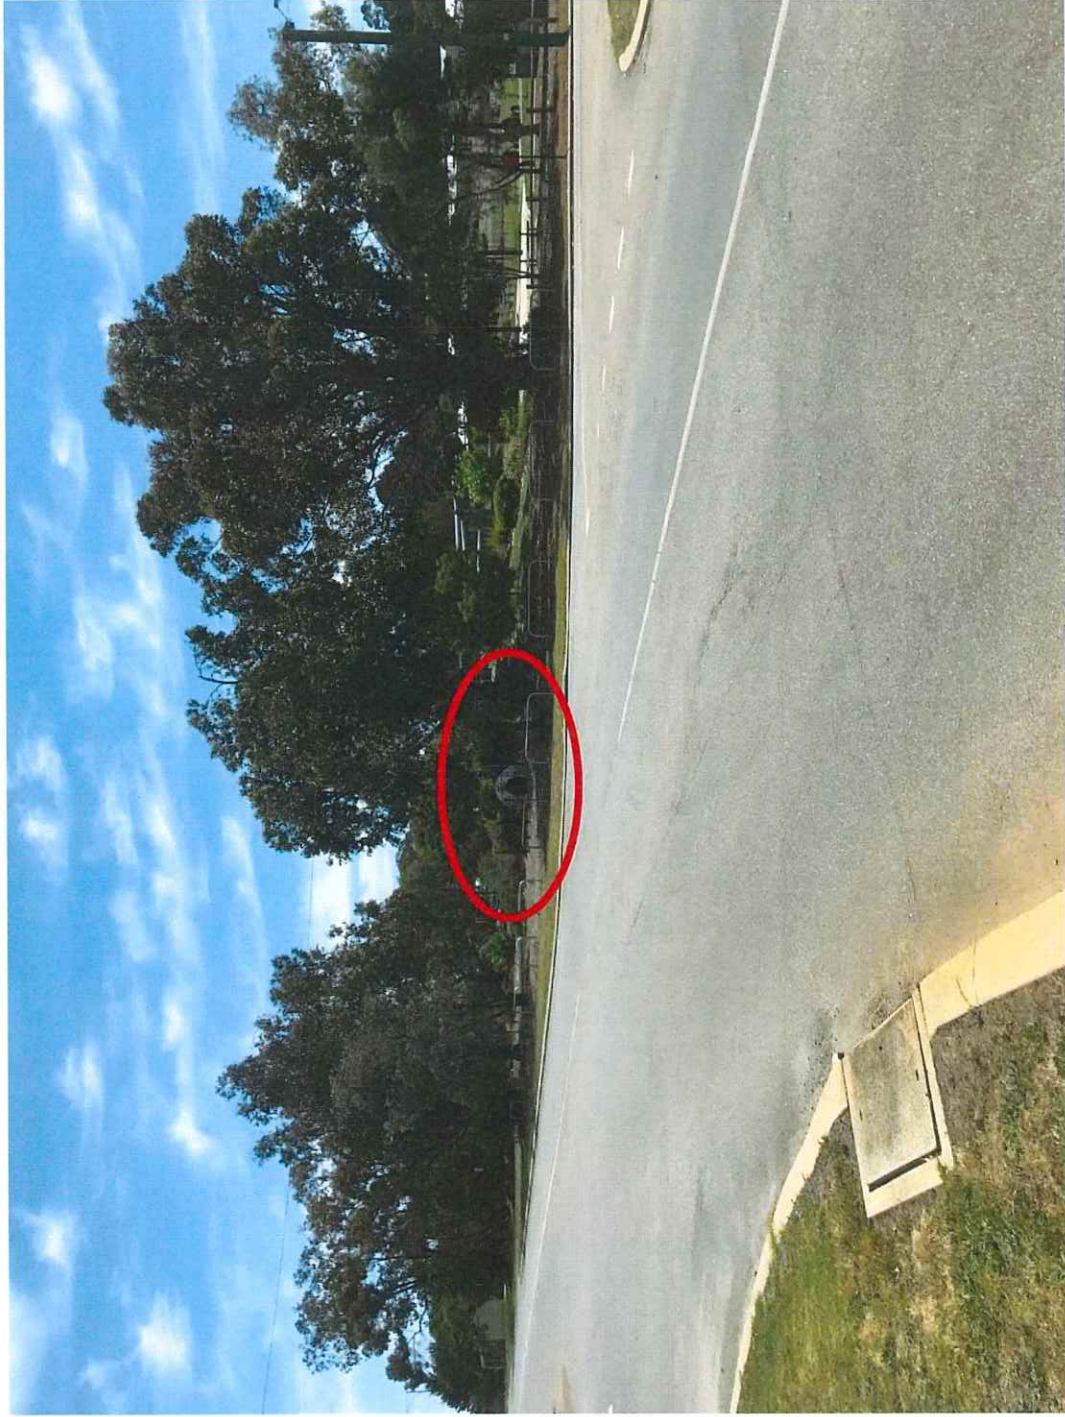
View looking north along Lowwood Road. Note raised landscaping and tunnel exit point.

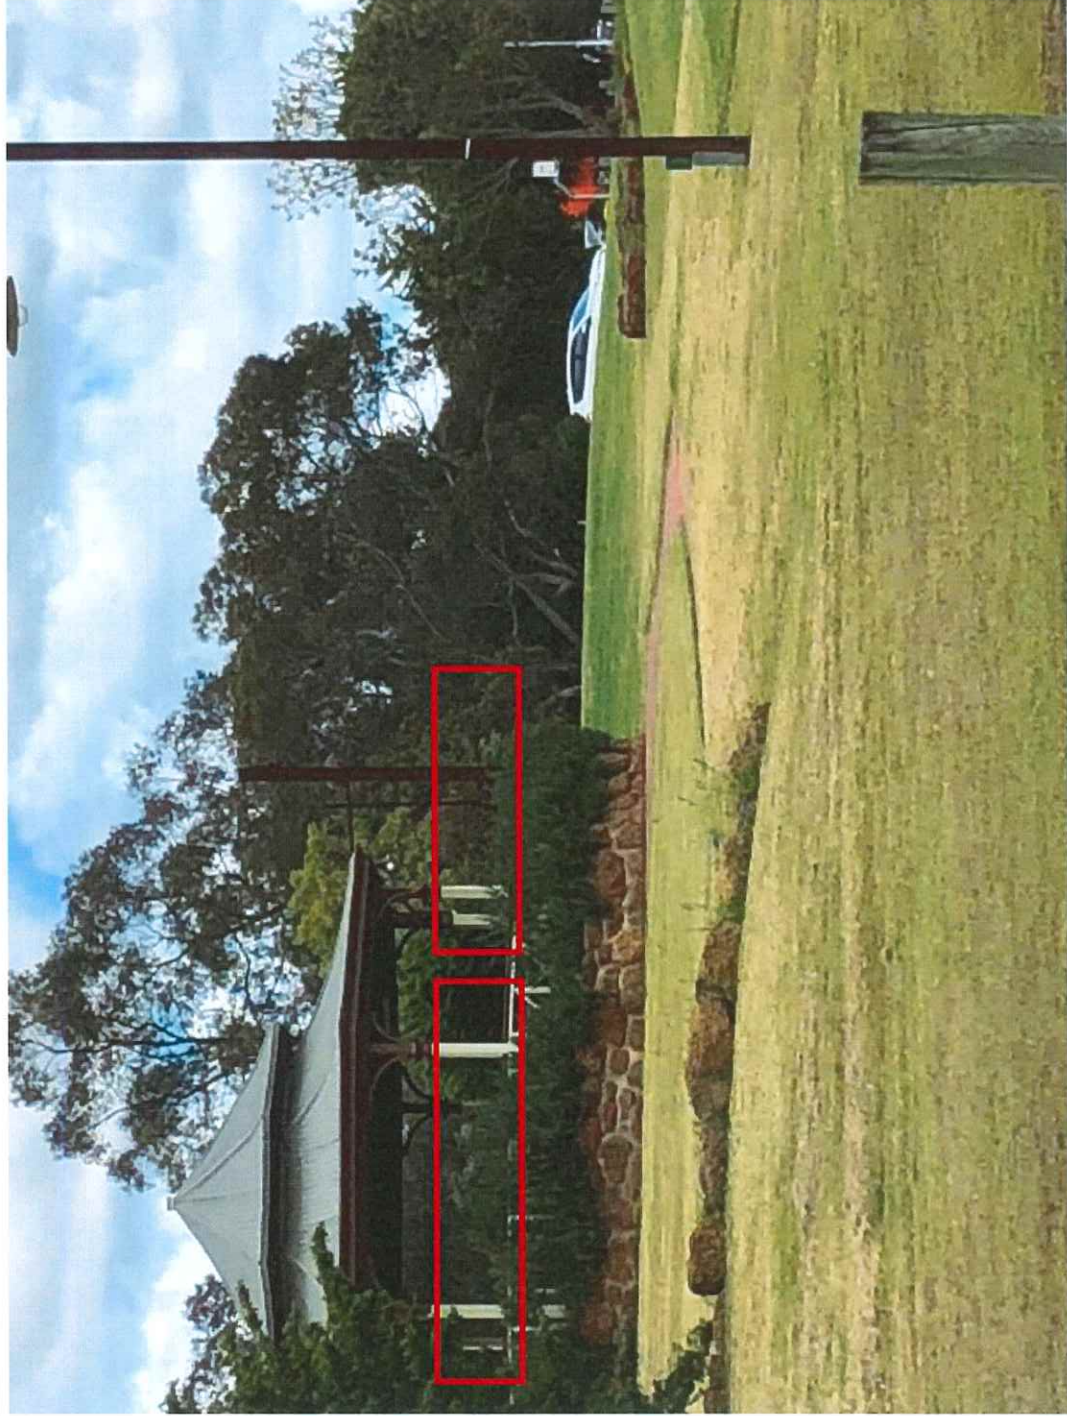
Gazebo-vegetation around this structure could be pruned to improve sight lines.

- Signage could be installed in the play area encouraging visitors to supervise the activities of children.
- Work could be undertaken to the landscaping within the park where it borders Lowood Road with vegetation pruned to allow improved sight lines. Similar work could be undertaken around the gazebo to allow better sight lines to the rail line and park area more broadly.
