DEVELOPMENT APPLICATION P867 – PROPOSED  
ANIMAL HUSBANDRY-INTENSIVE (CATTLE  
FEEDLOT) AT NO. 144 (LOT 150) PICKLES ROAD,  
NARRIKUP

- A – Development Application P867
- B – Public Submissions
- C – Agency Referral Responses

Meeting Date: 28 October 2025

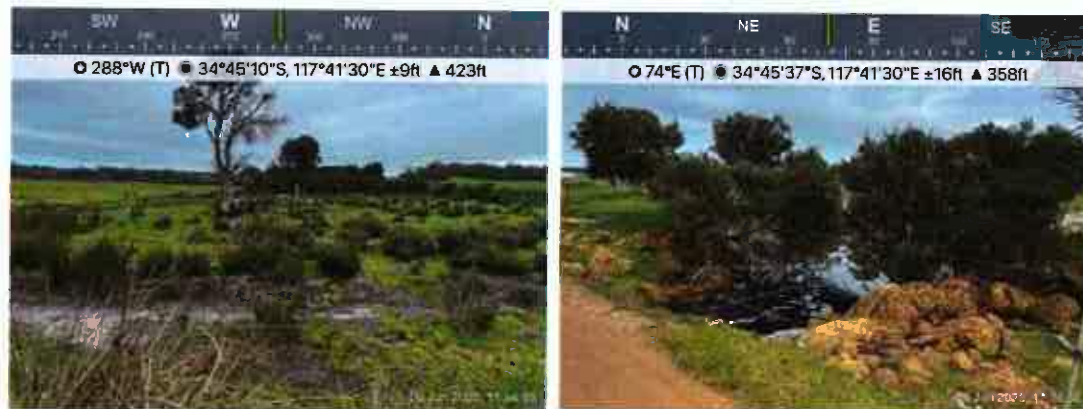
Figure 6: Surrounding creek lines to the south.

To the south of the property in adjacent grazed land is another minor tributary flowing to the south west, refer to Figure 6 below and Figure 10: Buffer Mapping, Appendix A.

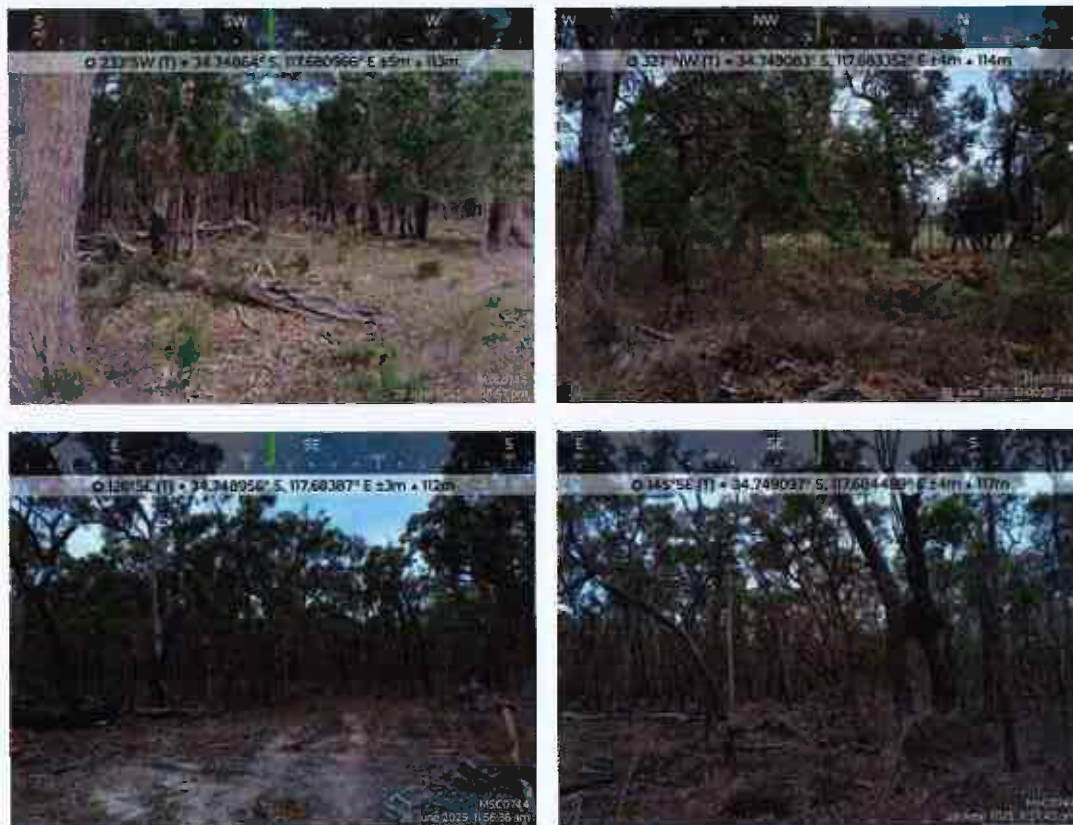
Figure 7: Photographs of remnant Jarrah-Marri forest to the south of the proposed cattle feedlot pens.

Most of the property has been historically cleared of native vegetation for the purpose of agriculture. Pockets of remnant Jarrah-Marri forest vegetation of varying sizes have been retained. The remnant vegetation is in predominantly good condition. It should be noted that no remnant vegetation is proposed to be cleared for the development of the cattle feedlot. See Figure 7 for example photographs of the remnant vegetation to the south of the proposed cattle feedlot pens.

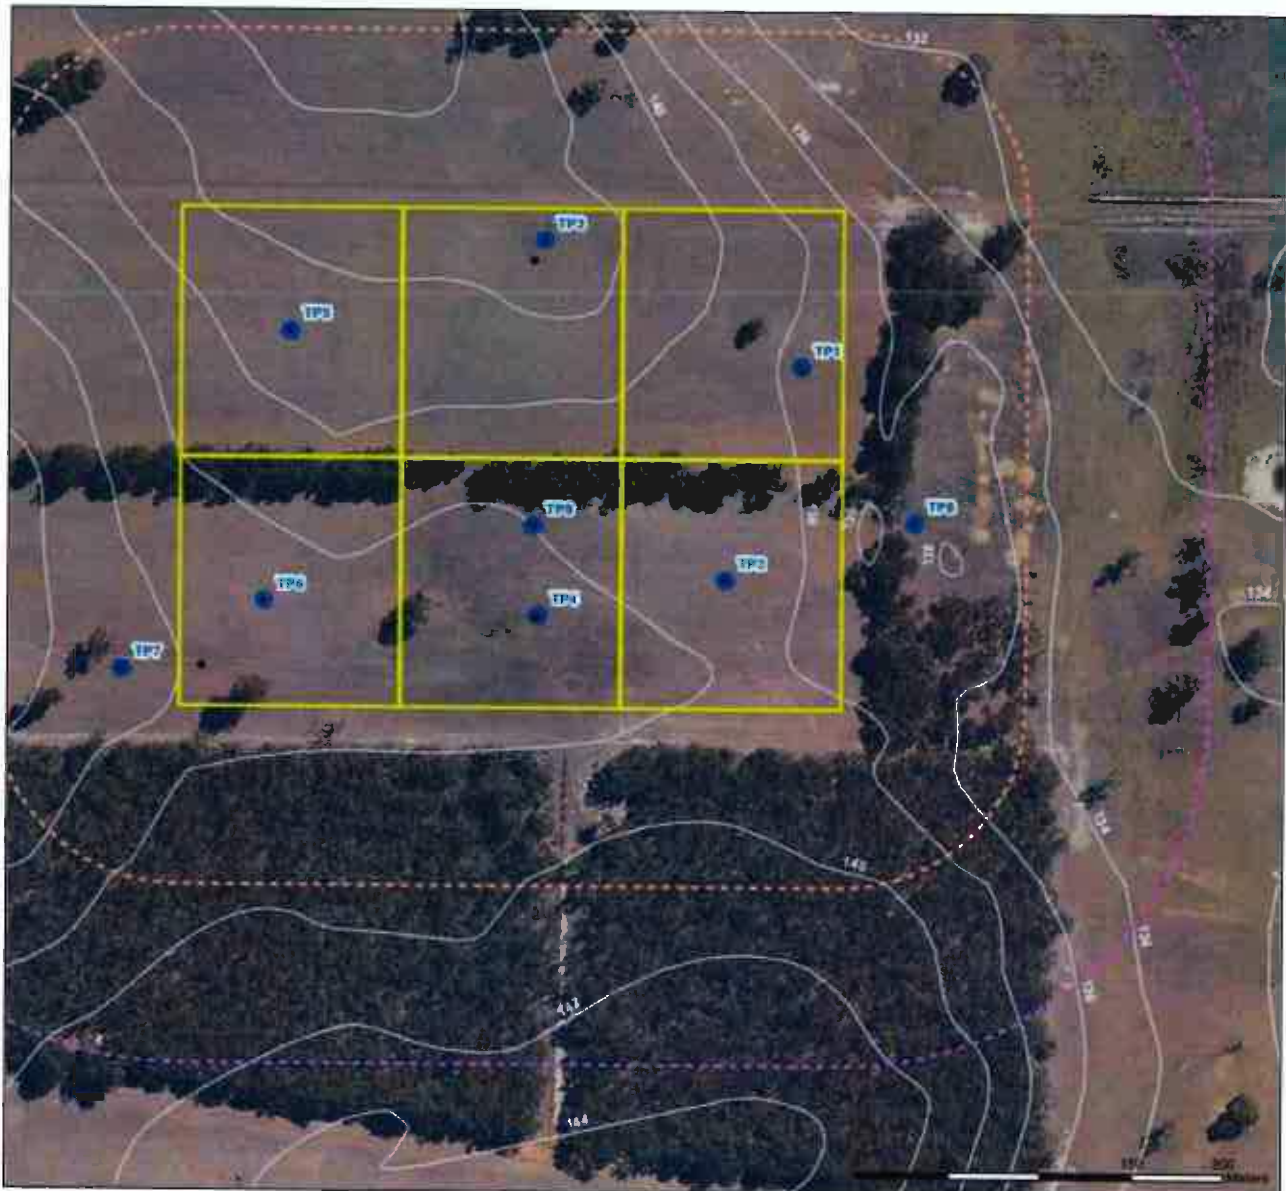
### Test Pit Locations

Site conditions and test pit locations were recorded and are displayed in [Appendix A - Maps](#).  
Test pits logs/ soil profiles are noted in [Appendix B - Test Pit Logs](#)

Test Pits 1 to 9

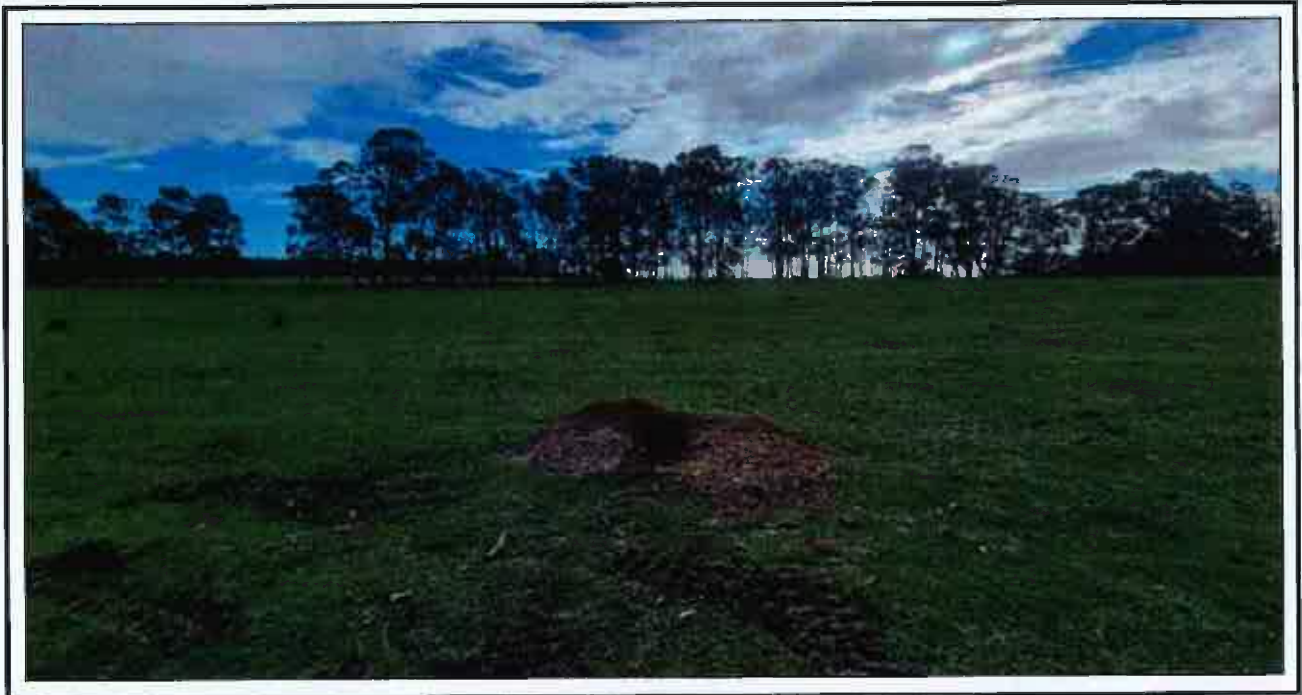
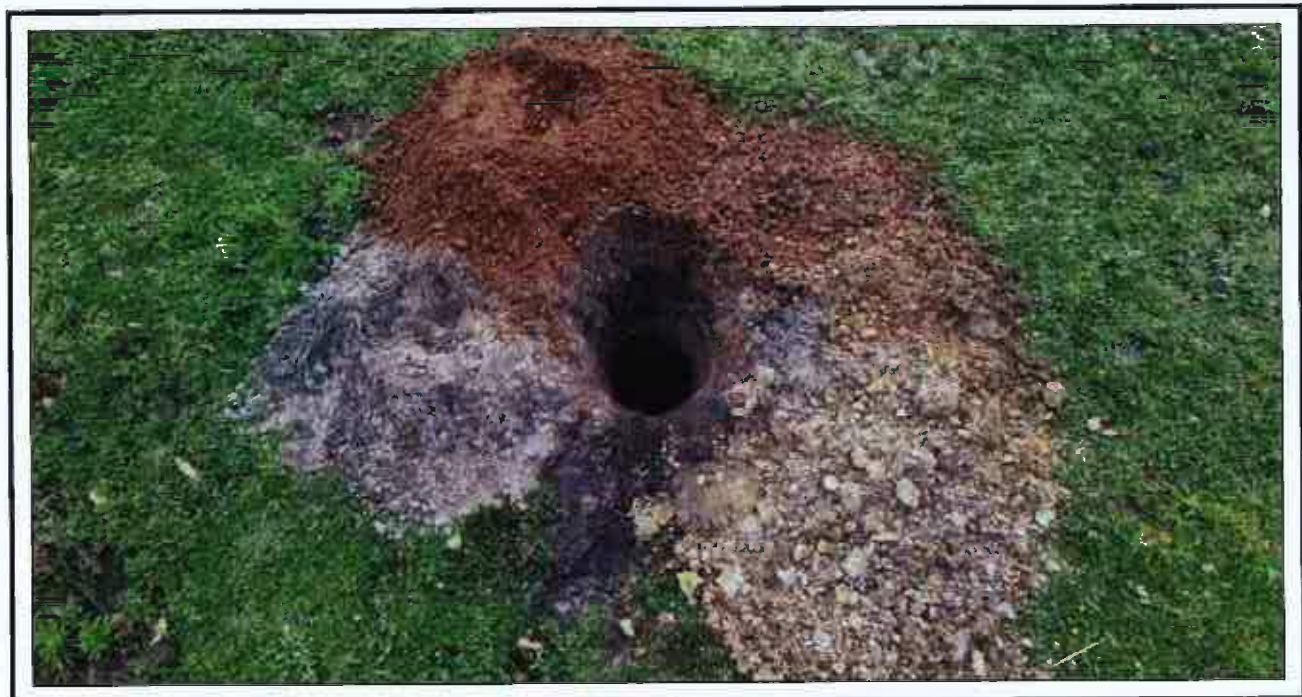
## Test Pit No.4

| Depth Below Surface<br>(mm) | Layer Depth<br>(mm) | Material Description<br><br>SOIL TYPE, Plasticity, Colour,<br>Particle characteristics, Secondary and other minor components | Moist. Condition | Consistency / Strength | Cementation | Water Table | Classification Symbol | Sample/Test |
|---|---|---|---|---|---|---|---|---|
| | | | | | | Water table noted at 1.1m below existing ground level. | | |

Soils across the subject site were found to be generally consistent, comprising of topsoil (sand with silt) overlying a mix of sandy duplex soils with clay and gravel. The only water table encountered was within TP4 and was at 1100 mm from ground level after 1 hour. The final design of the proposed cattle feedlot pens has been altered to accommodate this high groundwater table. A summary of the site soils as classified by Great Southern Geotechnics is found in Table 2.
