ASSET MANAGEMENT STRATEGY – MOUNT BARKER PATHWAYS IMPROVEMENT PROGRAM

Pathways Improvement Program Proposal

November 2021

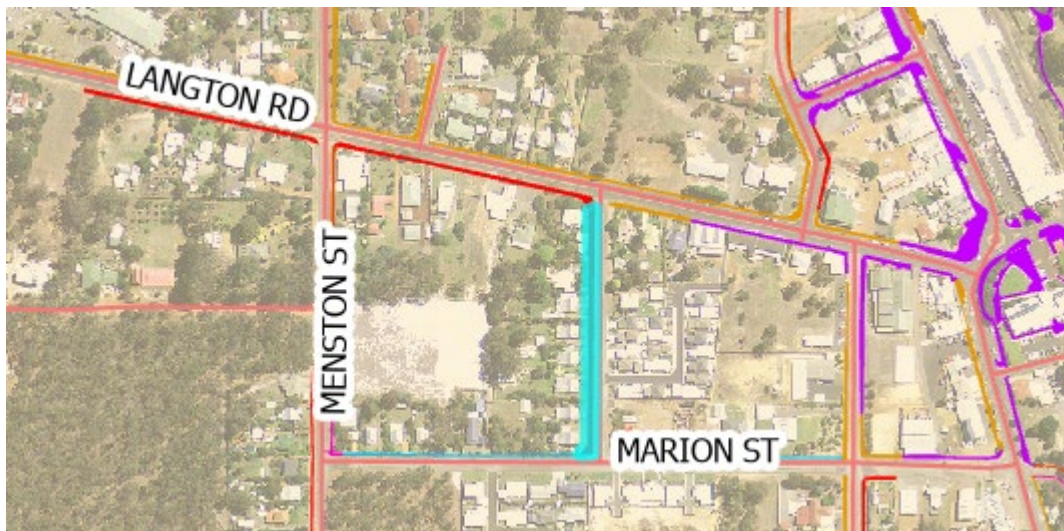
Location Plan

Project:	Program	Year	Current Condition			
Eaton Ave Langton Rd to Marion St	Disposal	2022/23	(5) Very Poor			
Scope	Verge Reinstatement. Blend existing surface, 1% cement stabilize, water bind & compact					
ASSET INFORMATION	Asset Class	Footpaths	Expansion	Upgrade	Renewal	Disposal
	Sub Class					100%
Cost Estimate						
Activity	Unit	Quantity	Rate	Amount		
Verge Reinstatement	LM	200	\$8.00	\$1,600		
Traffic Management	² M	2	\$180	\$360		
Contingency	%	10		\$196		
Total				\$2,156

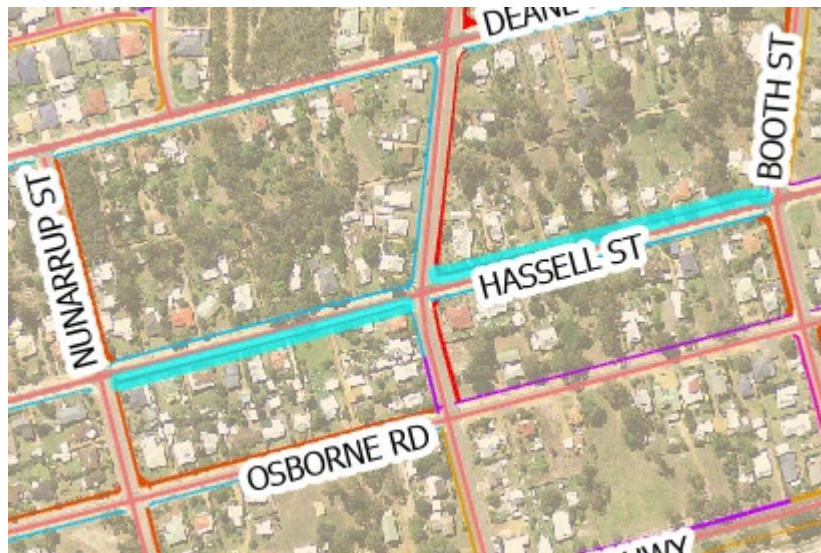
Location Plan

Project:	Program	Year	Current Condition
Hassell St Muir St to Langton Road	Disposal	2022/23	(5) Very Poor

Scope	Verge Reinstatement. Blend existing surface, 1% cement stabilize, water bind & compact					
-------	--	--	--	--	--	--

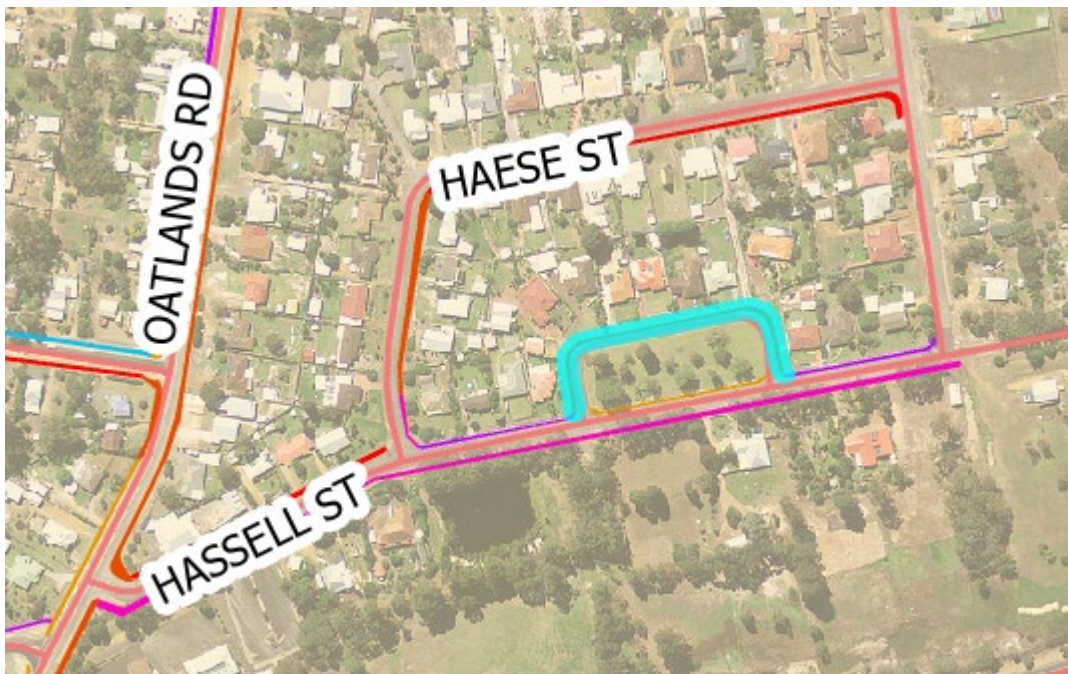
Location Plan

Project:	Program	Year	Current Condition
Bonnyup St Hassell St to Hassell St	Disposal	2022/23	(5) Very Poor

Scope	Verge Reinstatement. Blend existing surface, 1% cement stabilize, water bind & compact					
--------------	--	--	--	--	--	--

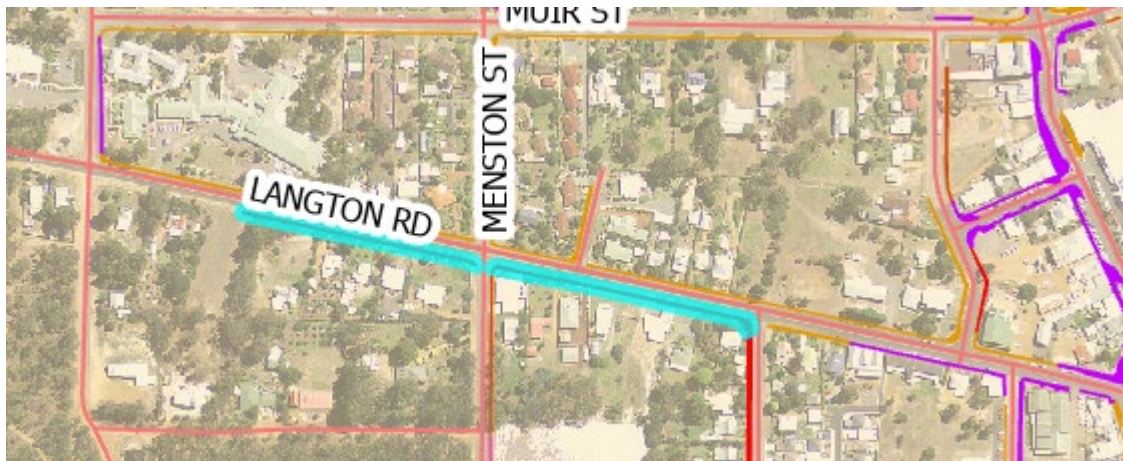
Location Plan

Project:	Program	Year	Current Condition			
Langton Road	Disposal	2022/23	(5) Very Poor			
Scope	Verge Reinstatement. Blend existing surface, 1% cement stabilize, water bind & compact					
ASSET INFORMATION	Asset Class	Footpaths	Expansion	Upgrade	Renewal	Disposal
	Sub Class					100%
Cost Estimate						
Activity	Unit	Quantity	Rate	Amount		
Verge Reinstatement	LM	410	\$8.00	\$3,280		
Traffic Management	² M	20	\$180	\$3,600		
Tree Removal	Ea	21	\$180	\$3,780		
Contingency	%	10		\$10,660		
Total				\$11,726

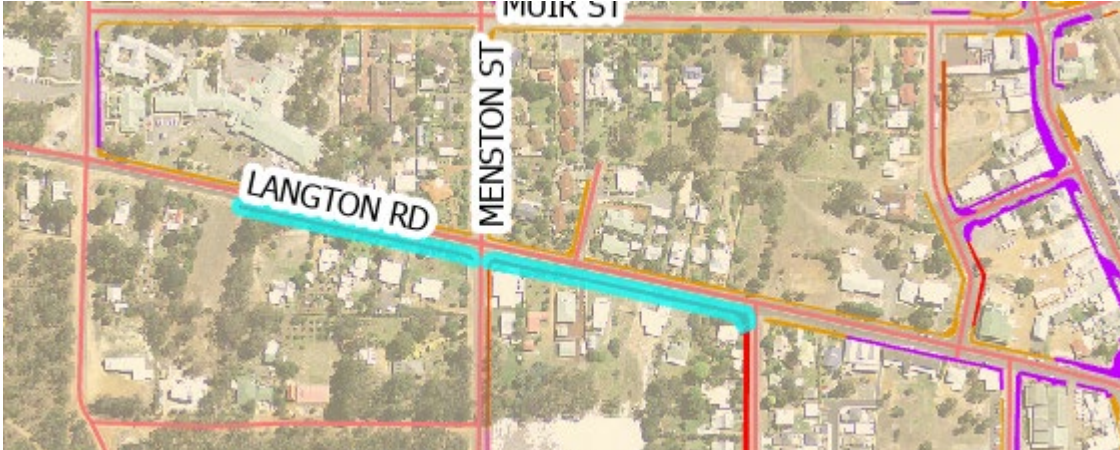
Project:		Program		Year		Current Condition	
Langton Road Street Scope		Upgrade		2022/23			
Scope		Remove barrier kerbing from southern side of the road Cut existing surface 4.6m south from the current centreline Remove existing seal from cut line to the kerbing Construct Swale Drain and small check dams on verge uphill from intersecting road, tie into existing crossovers					
ASSET INFORMATION		Asset Class	Footpaths	Expansion	Upgrade	Renewal	Disposal
		Sub Class					100%
Cost Estimate							
Activity	Unit	Quantity		Rate		Amount	
Cut bitumen, Trench, install flush kerbing	Lm	410		\$100		\$41,000	
Reseal 5 & 7 mm chip blend	² M	8020		\$5.5		\$44,110	
Remove Kerbing, construct rip rap swale drain and small check dams where gradient is greater than 4% and tie into existing road crossing.	Lm	320		\$115		\$36,800	
Street trees and sedges removal and replanting.	Ea	21/100		\$350		\$11,500	
Survey & Design	%	20				\$38,100

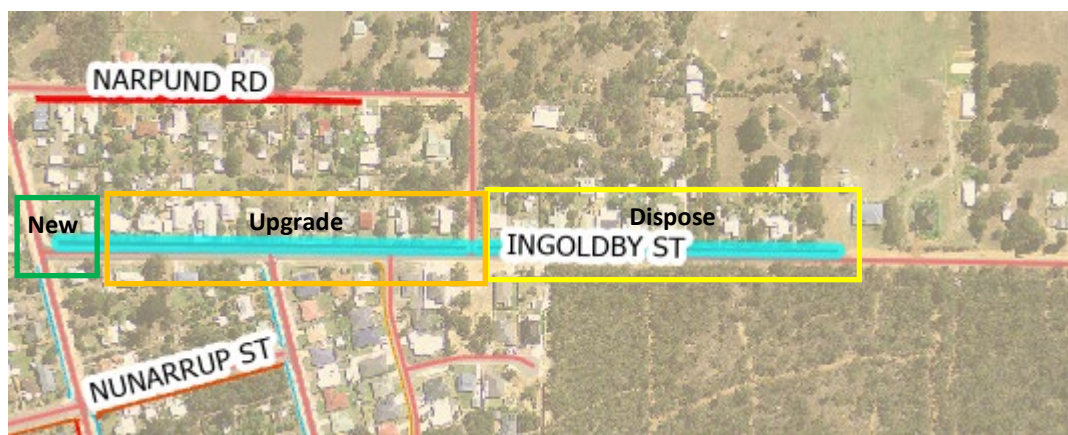
Location Plan

Project:	Program	Year	Current Condition
Ingoldby St Hassell St to Bunker St	Upgrade / New	2021/22	(4) Poor
Bunker St to #47 Ingoldby St	Disposal	2021/22	(5) Very Poor

Scope	<ul style="list-style-type: none"> Prune and remove vegetation from the existing surface and clearance zone Sweep and patch existing path surface Reconstruct failing areas, with tack coat Apply 25mm hot asphalt overlay to existing seal Construct 15 metres of path to connect existing path with Hassell St Construct pram ramp at the intersection of Hassell and Ingoldby Sts Tie into or lift existing serves to match level of new path <u>Verge Reinstatement</u>. Blend existing surface, cement stabilize, water bind & compact (Bunker St to #47 Ingoldby St) 					
--------------	--	--	--	--	--	--

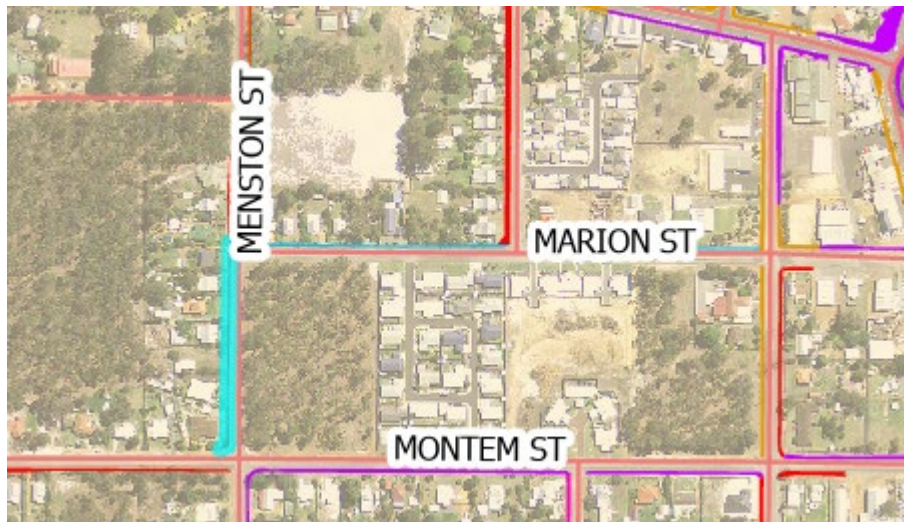
Location Plan

Project:	Program	Year	Current Condition
Menston St Montem St to North Boundary No 27 Menston St	Upgrade	2022/23	(4) Poor

Scope	<ul style="list-style-type: none"> Prune and remove vegetation from the existing surface and clearance zone Sweep and patch existing path surface Apply 25mm hot asphalt to 2 metre width central to existing seal Tie into or lift existing serves to match level of new path
--------------	--

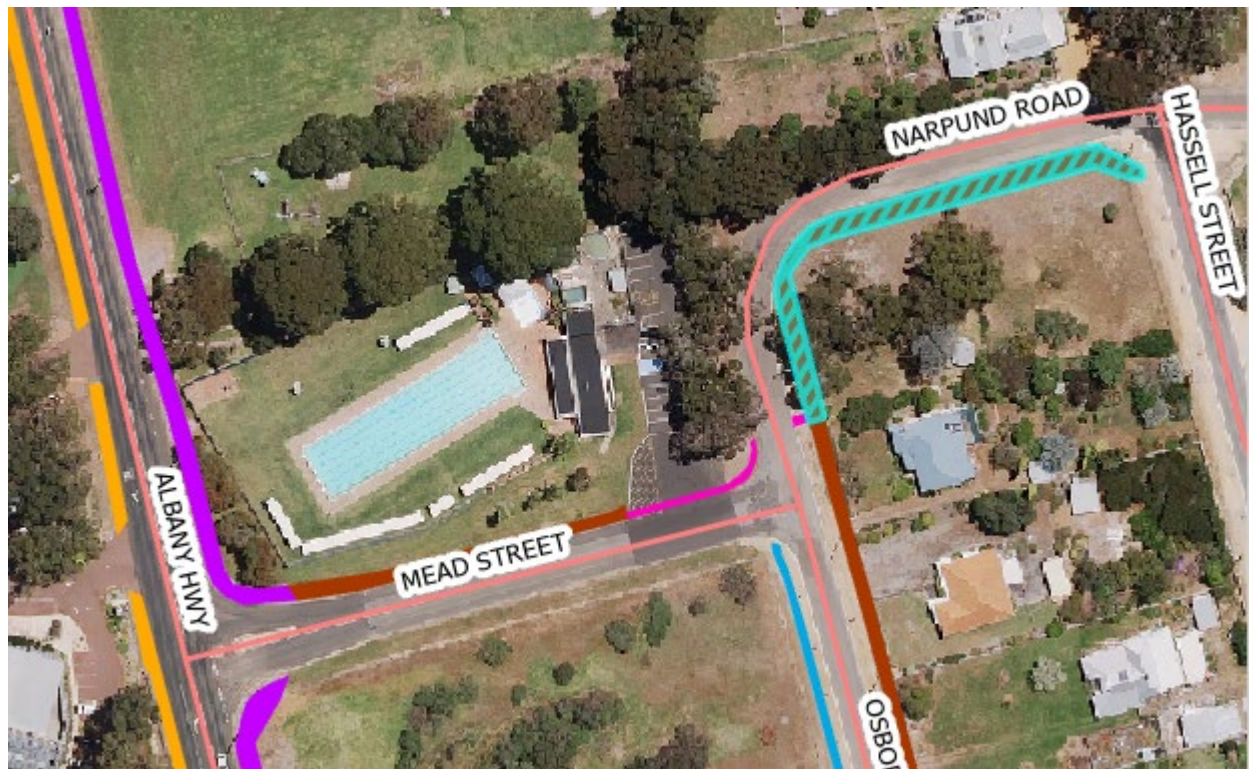
Location Plan

Project:	Program	Year	Current Condition
Narpund St / Osborne Rd	Upgrade	2022/23	(4) Poor

Scope	<ul style="list-style-type: none"> • Prune and remove vegetation from the existing surface and clearance zone • Sweep and patch existing path surface • Apply 25mm hot asphalt to 2 metre width central to existing seal • Tie into or lift existing serves to match level of new path • Tie into existing crossovers 					
	Renew verge treatment Narpund Rd Hassell St to Osborne Rd, Edge of path to back of kerbing

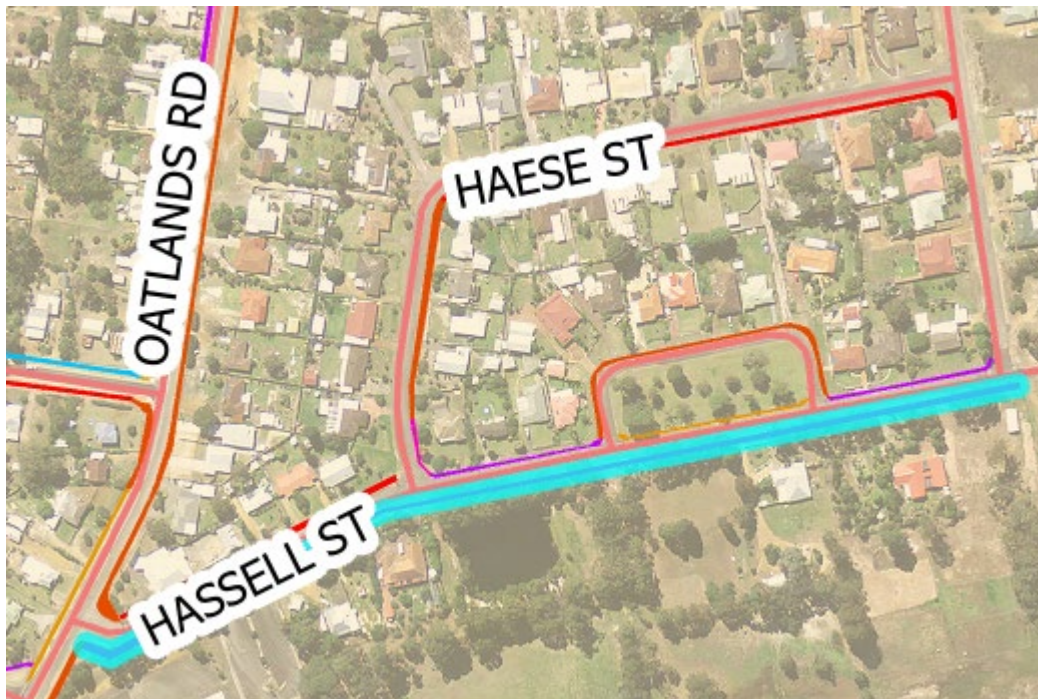
Location Plan

Project:	Program	Year	Current Condition
Hassell St Oatlands Rd to Atherton St	New	2022/23	(0) Proposed

Scope	Construct new shared path to two metres wide behind kerb. WABN Funding of \$24,700					
-------	---	--	--	--	--	--
